CDF/DOC/CDF/PUBLIC/5903
May 6, 2002

Radiation Effects in CDF Switching Power Supplies

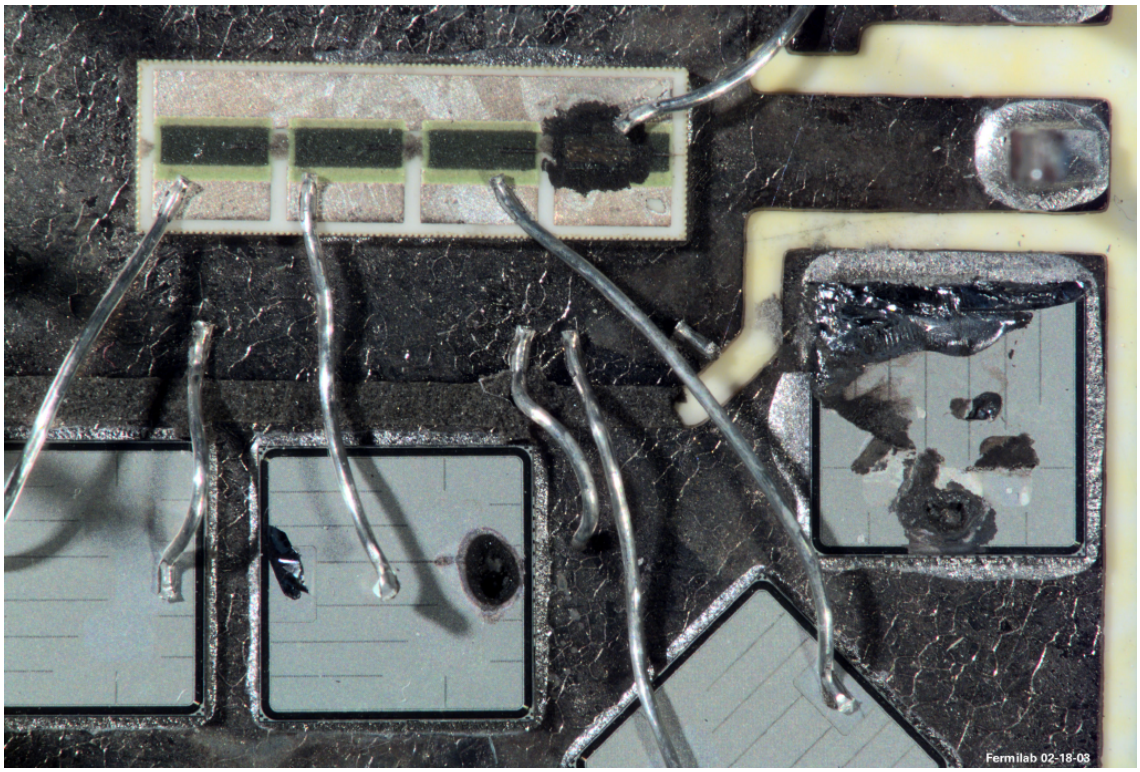
After initial burn in, those VME power supplies located in the CDF collision hall were observed to fail at a rate of approximately one per week [1]. The nature of these failures became particularly evident on November 25th (Saint Catherine's day) when 12 VME power supplies failed in a single day. Analysis of these failures found that a single component failed in all cases. For the VME supplies, the component which failed was a 500 V, n-channel, power metal oxide silicon field effect transistor(MOSFET). This device is the switching transistor of the AC/DC power factor corrector module for the power supply. It switches 385 volts at 100 kHz. Figure 1 is a photograph of a failed component from one of the VME power supplies.

The characteristics of the component failures are consistent with a mechanism known in the literature as single event burnout (SEB). The SEB mechanism can be thought of as the biased transistor behaving as a slightly more complicated version of an ionization chamber. An ionizing particle passing through the transistor creates a narrow (diameter $\approx 1\mu$m) sheath of electron-hole pairs in bulk of the transistor. When the drain-source bias (V_{ds}) is large enough, the electrons and holes drift in the applied electric field. The resulting current density can be in excess of 10^4 A/cm^2. The vertical current deflects to flow laterally in the insulator-silicon interface to the body region. This flow induces a voltage drop between the P-body and the source regions (V_{bs}). The source, P-body and N-Epi regions form an effective N-P-N bipolar transistor. When V_{bs} exceeds 0.7 V the bipolar transistor is forward biased. Under the forward bias, a positive feedback is established and the local current density surrounding the track is increased by several orders of magnitude. Heating from the high local power density

Figure 1: Failed power MOSFETs in a hybrid circuit as part of the CDF VME power supplies. Note the loss of wire bonds and fracture of the silicon indicating a catastrophic failure.

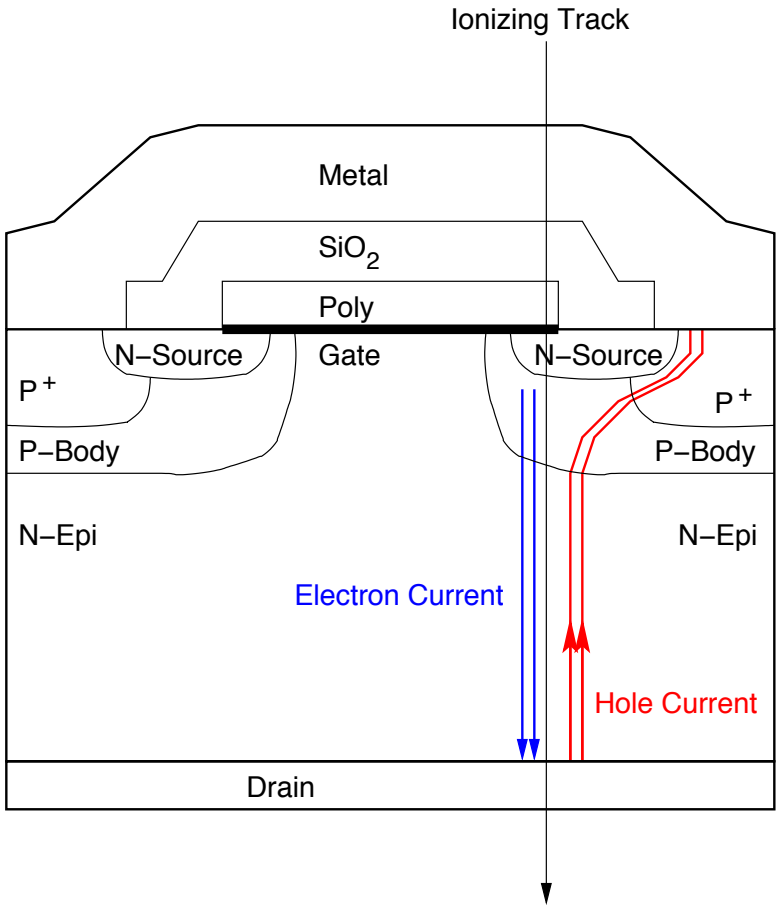
may be sufficient to sublimate the silicon, resulting in catastrophic failure. Figure 2 shows a schematic of this process. In the above mechanism, the failure is related to the local ionization from the radiation, the bias voltage applied to the transistor and the stored energy in the transistor circuit. There are N-channel MOSFETs in the market which are designed to be SEB robust. Another technique for minimizing this type of effect in a given radiation environment is to operate the transistor far from its maximum operating voltage (de-rating the transistor). A comprehensive overview of this subject may be found in Titus and Wheatley's 1996 article [2].

Figure 2: Schematic diagram of the mechanism for single event burnout (SEB).

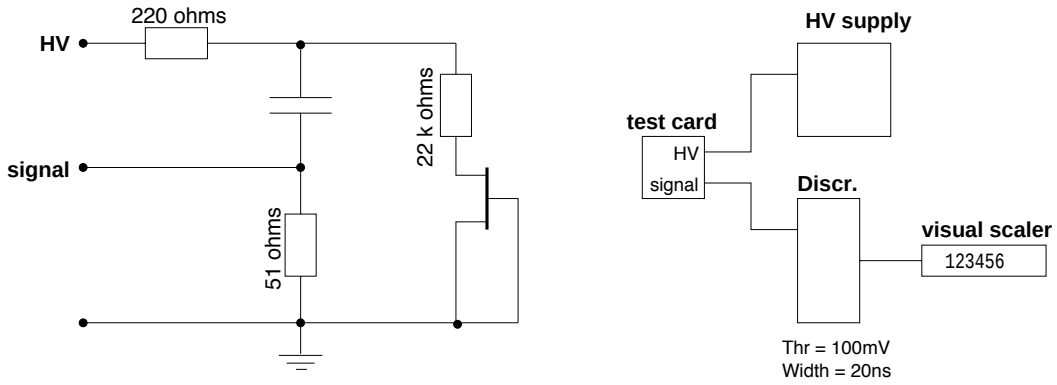
These boards were installed in the CDF collision hall on top of the low beta quadrupoles, east of the CDF detector. Figure 3 shows the setup used in the CDF collision hall. Figure 4 shows an oscilloscope trace of a SEB failure signal.

Figure 3: Transistor test setup installed in the CDF collision hall and Fermilab booster radiation damage facility.

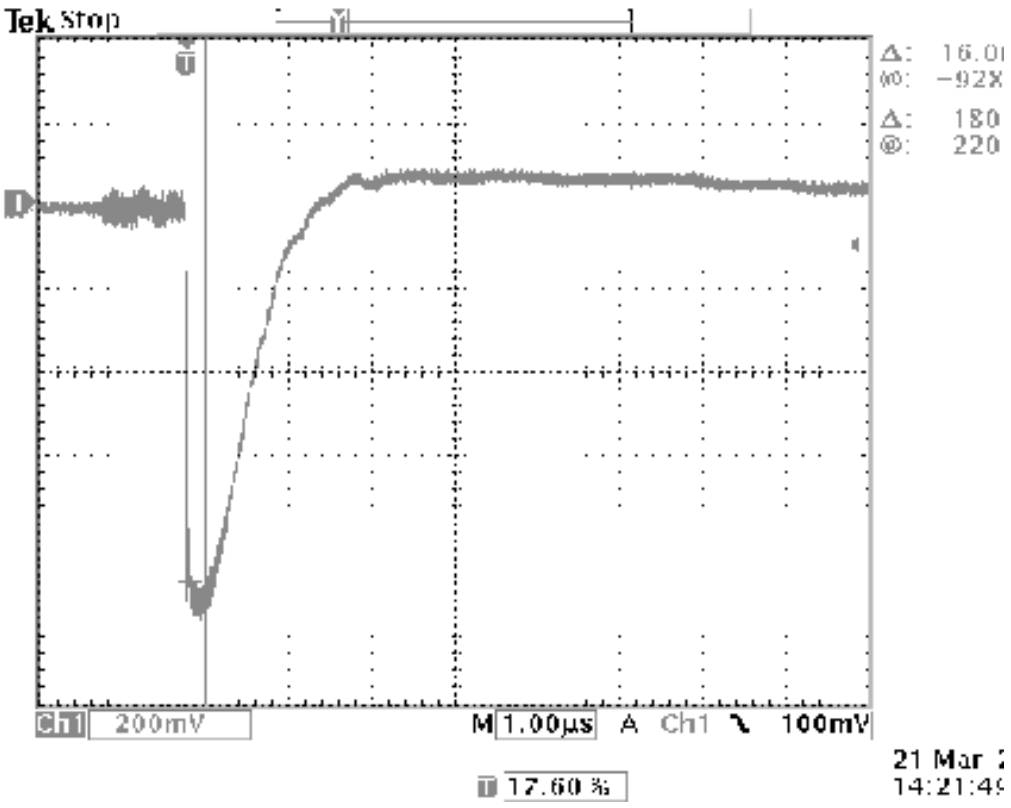
Figure 4: Oscilloscope trace of a typical SEB failure event.

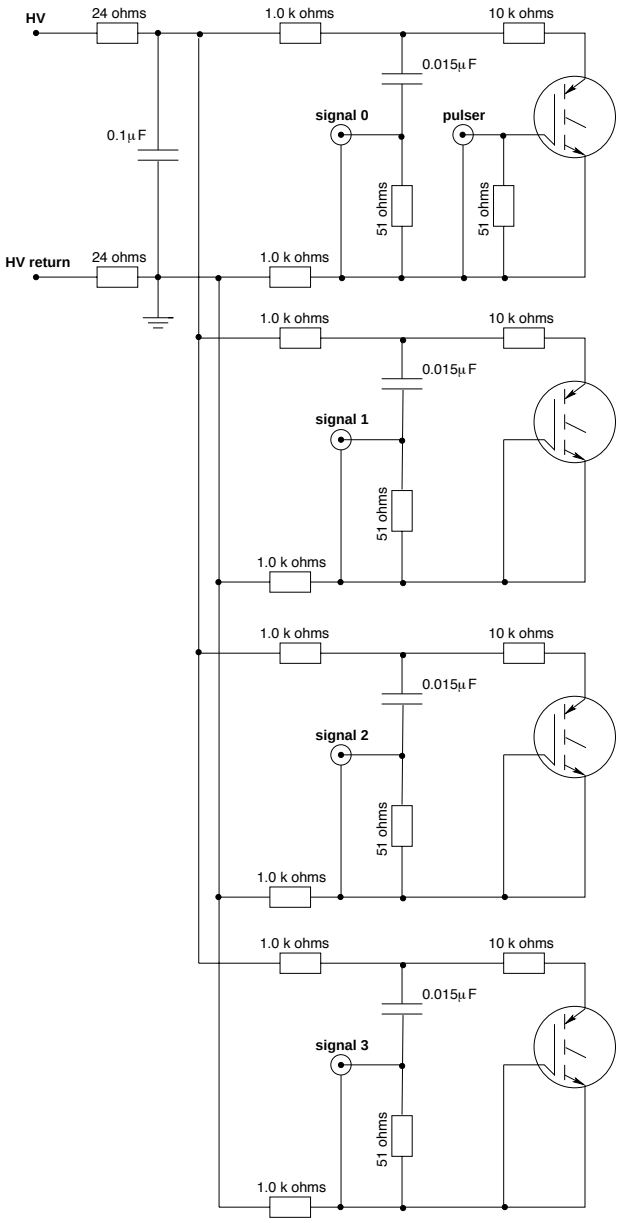
The setup for these tests was similar to that used in the CDF and booster evaluations. Four transistors were mounted to boards using the circuit shown in Figure 5 and supplied with a common bias voltage. The drain-source current from each transistor was then monitored with a discriminator scaler arrangement similar to that used in the CDF and booster tests. The transistors were centered in the beam and test pulses were sent to confirm signal continuity for one transistor. Each transistor was then irradiated using a 200 MeV proton beam with an average flux of 3–4×10^8 p/cm^2/s. The bias voltage was kept constant during the course of each irradiation which ranged from 0.5–2.0×10^{11} p/cm^2. In order to avoid total dose effects, we limited the total fluence delivered to 2.0×10^{11} p/cm^2 for any set of transistors. The SEB cross sections

Figure 5: Schematic drawing of the circuit used for transistor irradiation tests at the Indiana University cyclotron. For the SCR tests the same circuit board was used with the following modifications: the 10k resistors on the source side of the SCRs were replaced with a jumper wire, the 1k resistors on the HV supply side of the circuit were replaced with a 1M ohm resistor and the 51 ohm resistor in parallel with the pulser output was replaced with a jumper wire.

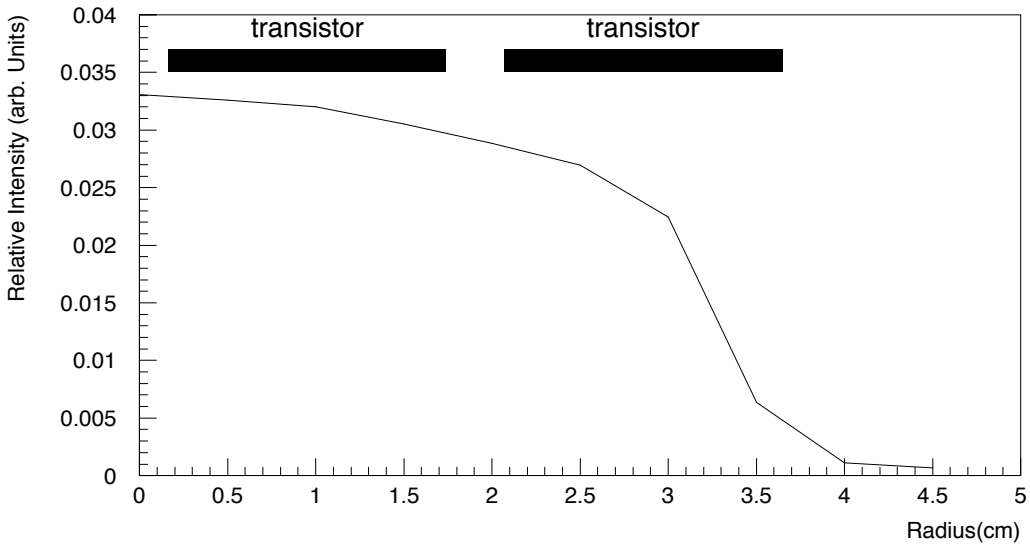
Figure 6: Proton beam intensity as a function of distance from the beam axis. Locations of transistors in the irradiations are superimposed.

The non-uniformity in the beam introduces a systematic bias in the mean cross section. The beam intensity profile is shown in Figure 6 with transistor locations superimposed. Integrating the beam profile over the area of the transistors and again averaging the results shows that the cross sections need to be corrected up by a factor of 1.30.

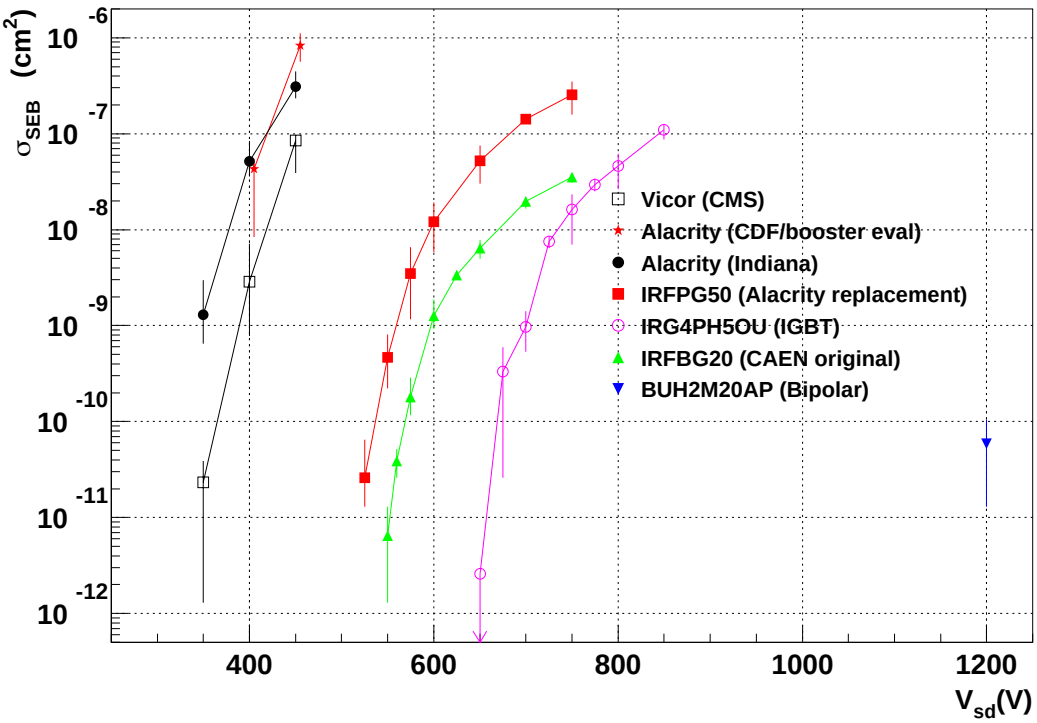
Figure 7: Measured SEB cross sections vs drain-source bias voltage (V_{ds}) for the transistors tested. The uncertainties indicate the spread in the data. The shaded region indicates the the upper limit on the sensitivity of our measurements.

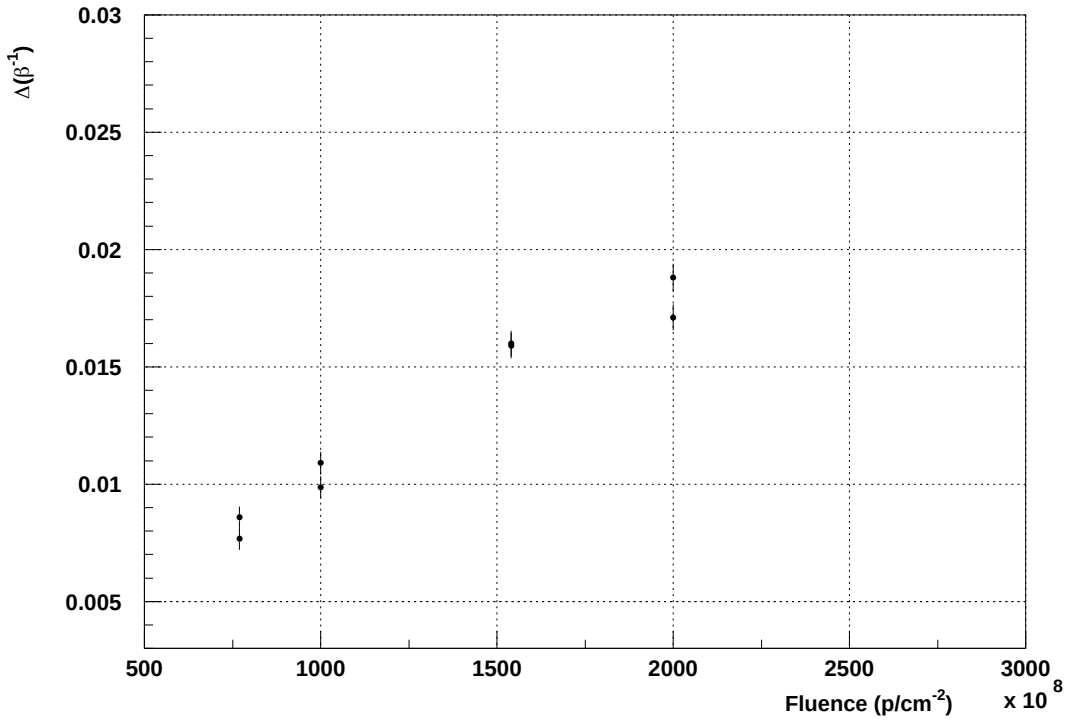
Figure 8: Change in the inverse gain ($\Delta(\beta^{-1})$) vs fluence for the bipolar junction transistors exposed at IUCF. The error bars are for the individual gain measurements whereas the distribution of the points is representative of the differences between individual transistors

The gains (β) of eight of the BJTs were measured prior to their irradiation in Indiana. They were then re-measured after a cool-down period of several weeks. For these measurements the collector-emitter voltage (V_{ce}) was 6V and the base current (I_{base}) was 1 mA. Results can be summarized in Figure 8.

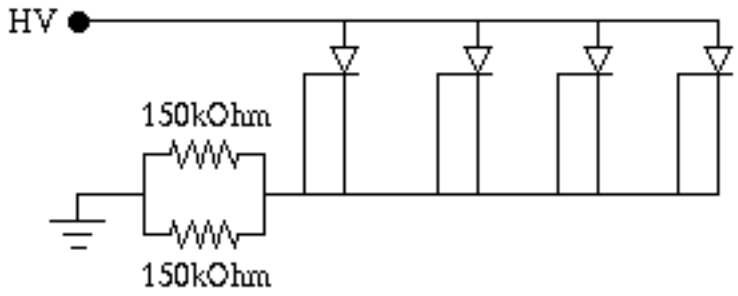
The test circuit for the SCRs had to be modified slightly from that used for the transistors to insure that the SCR did not remain active after a latch up event was recorded. A first test at the cyclotron was done at 550V using this test board. The board received a total fluence of 2×10^{11} p/cm^2 with no SEL events counted. Fearing that the test board was at fault, a simpler circuit shown in Figure 9 was

Figure 9: Modified SCR test circuit.

used for the next measurement. If an SCR in the second circuit were to suffer SEL the resulting current draw would have tripped the HV power supply. This board received a total fluence of 2×10^{11} p/cm^2 over a course of three runs with voltages up to 600V (the maximum rated voltage of the SCR). No latch up events where seen with the modified test board, although the leakage current in the SCR was observed to increase from approximately 700 nA to 1100 nA when the beam was running. A small amount of radiation damage was observed as an overall increase in the leakage current comparing before/after the irradiation. Table 2 summarizes the SCR leakage current observations.
